Operating Experience Summary

Office of Nuclear and Facility Safety

February 15 — February 29, 2000

Summary 2000-04

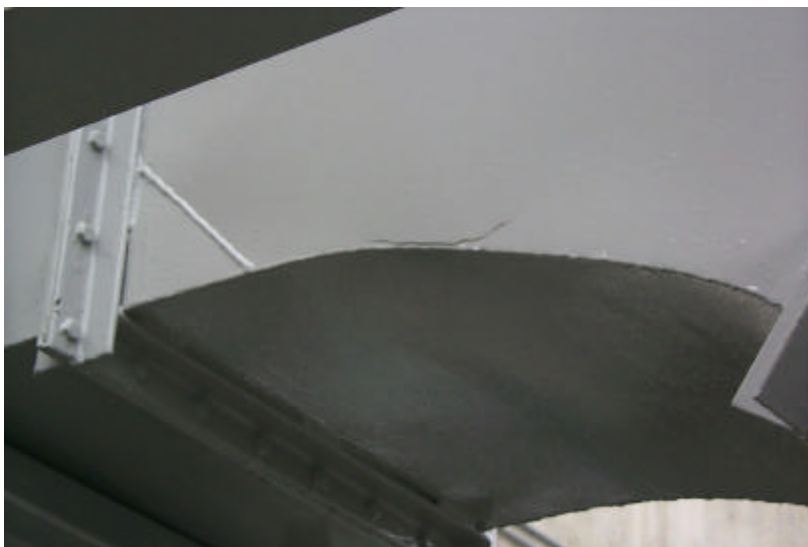
Figure 1-3. Crack Location

Investigators determined that this ventilation system had recently been installed because of cracks in the previous system. (ORPS Report RL--PHMC-BPLANT-1999-0003) The replacement ducting was placed in service on February 7, 2000 and on the following day two new cracks were discovered and the system was shut down. Figures 1-1, 2 and 3 show the configuration and the location of the cracks.

The exact nature of the 1999 failures was not reported in the final ORPS report of November 1999. The contractor installed the replacement system at no cost to DOE and believed that the changes would solve the problem. Investigators determined that the original ductwork was not designed, fabricated and installed to the *Sheet Metal and Air Conditioning Contractors National Association Construction Standard* as the original specifications required. The first occurrence was attributed to a failure to follow design code requirements.

The investigation determined that the system was designed for a range of flows from approximately 7,500 to 18,000 CFM, and the system had operated for about a year at the higher (normal) flow rate with no problems. The system flow rates changed in late summer 1999 to the lower design rate when one of the two filter trains was removed from service to replace the filters. The replacement system was started in February 2000, also at this lower flow rate. The investigators hypothesized that, since both failures occurred at the lower flow rate, this condition may be inducing stresses and causing the cracks. The investigators will review this and any other potentials before the system is repaired and restarted. EH will monitor the progress and report any significant findings in an update article.
